INFILTRATION ANALYSIS

**Campus Living
Ferguson Township, Centre County, PA**

CMT Laboratories File No. 1313800

May 28, 2013

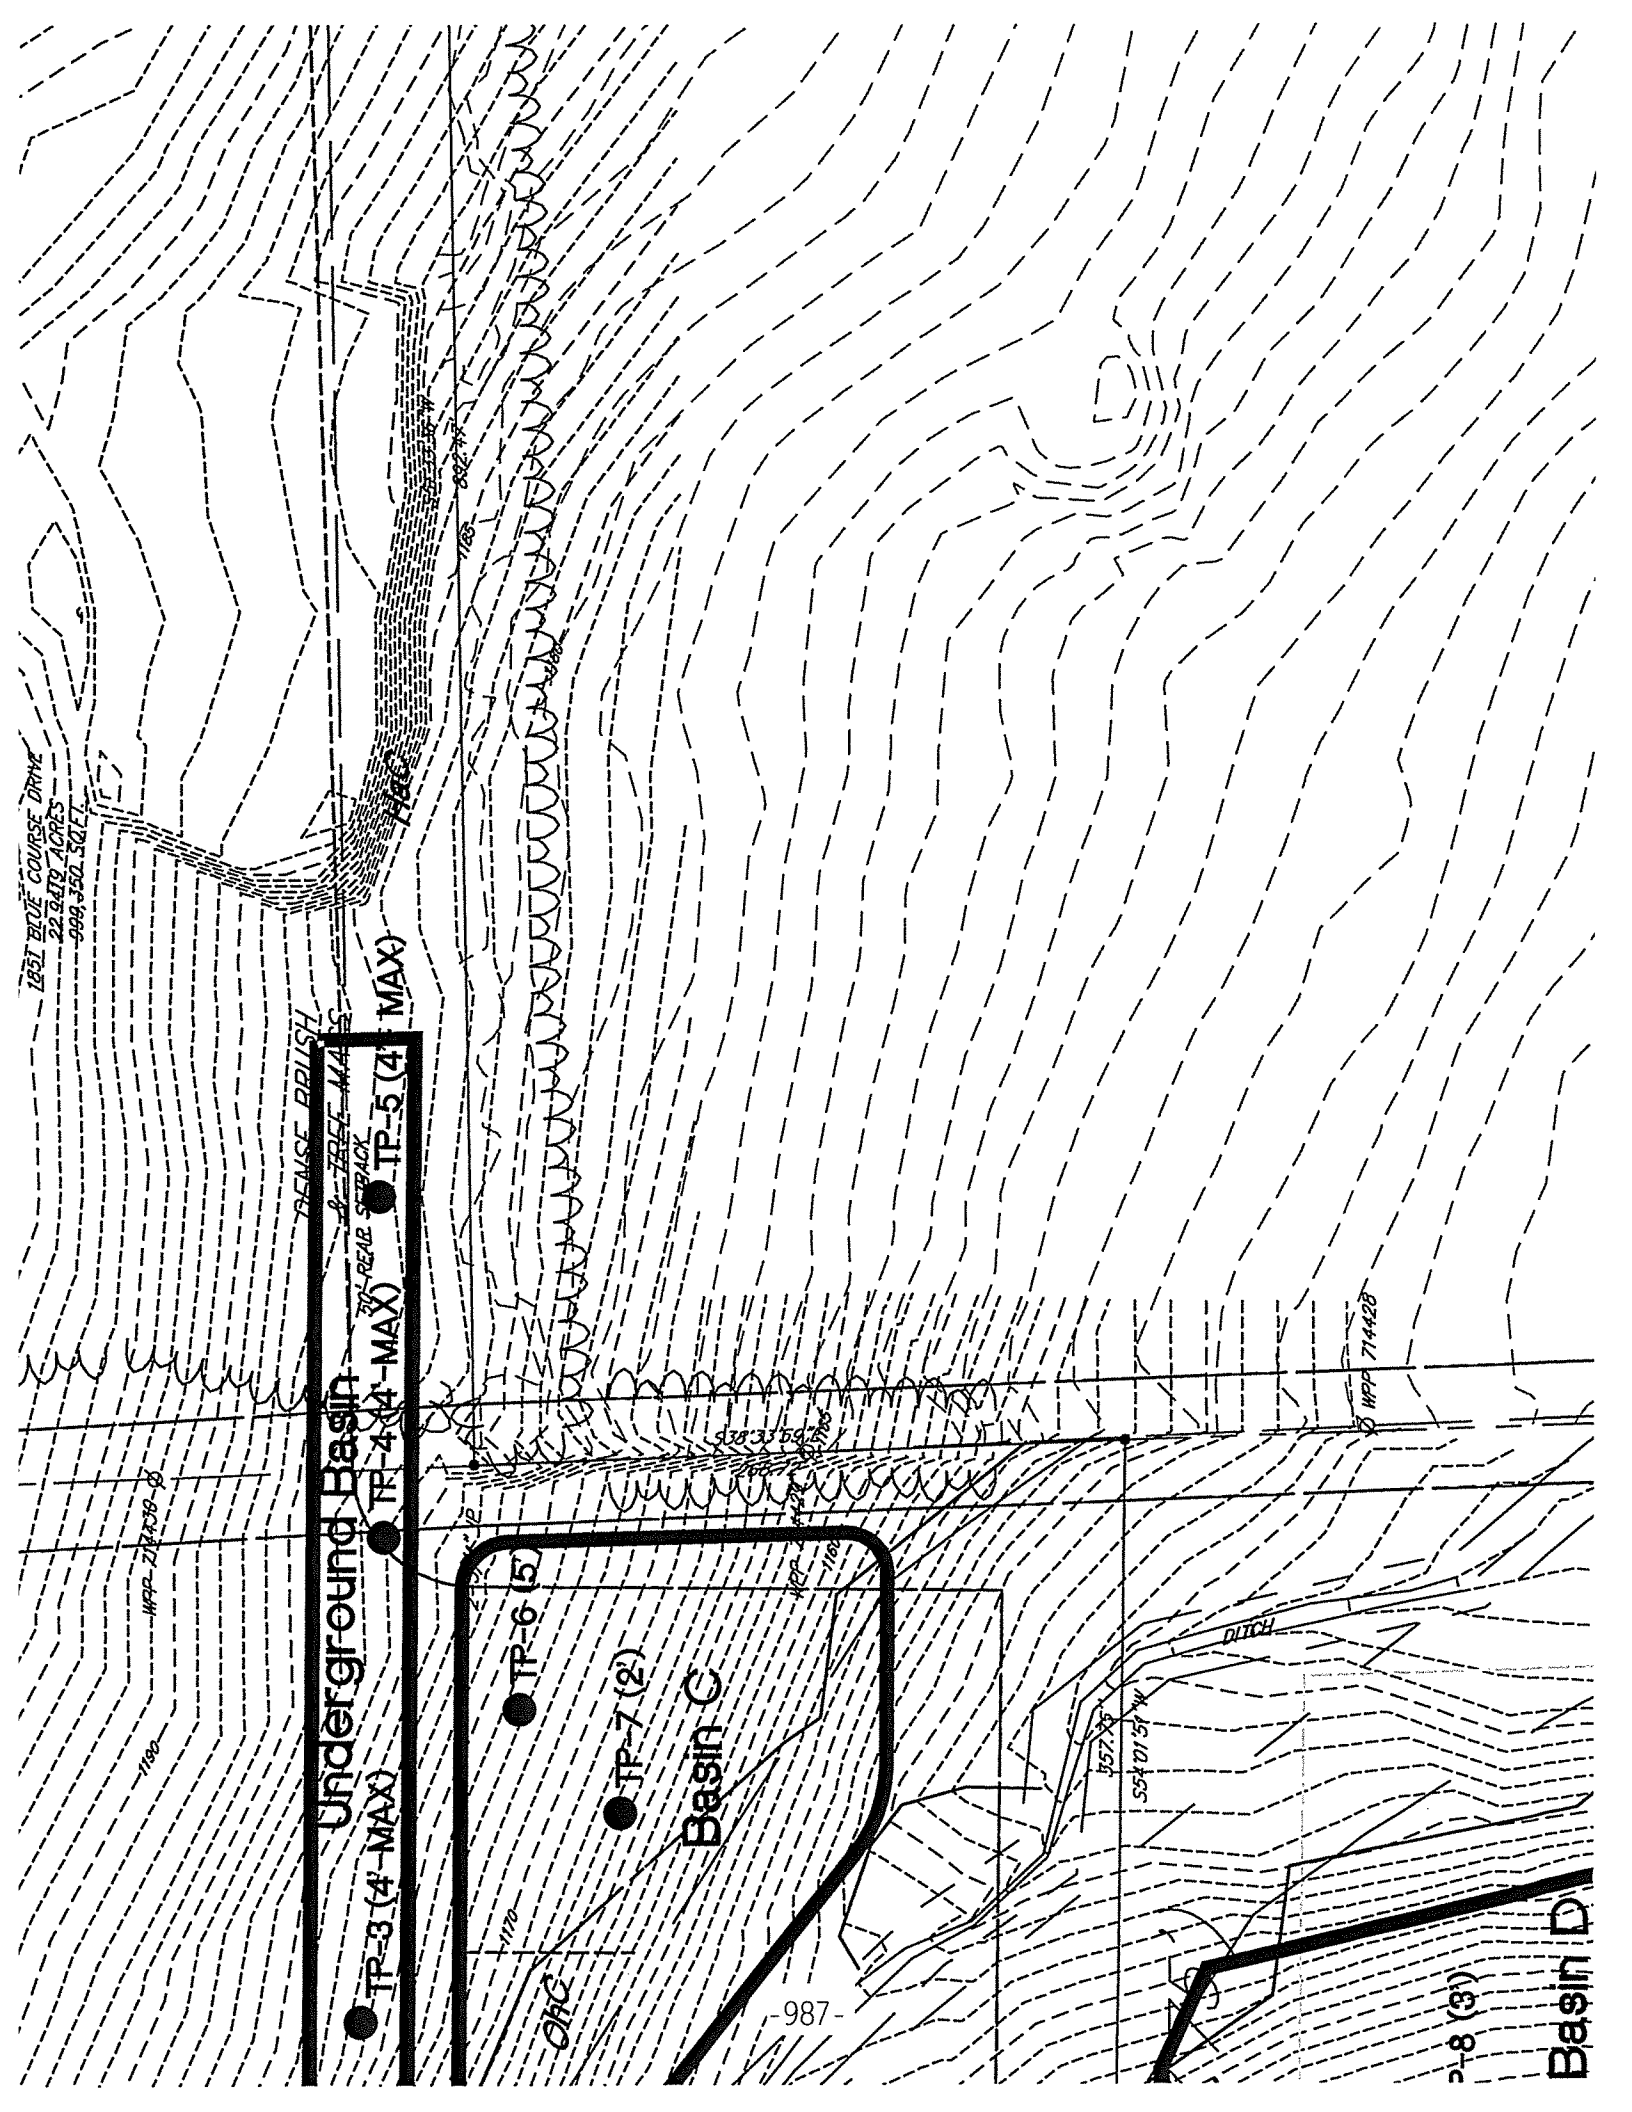
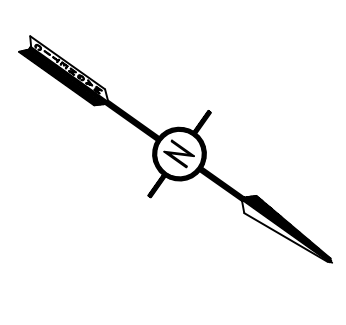
Test Pit Location Plan

<p>PROJECT NO. 12337</p> <p>DATE DECEMBER 19, 2014</p> <p>SCALE 1" = 30'</p> <p>SHEET NO. 1 of 1</p>	<p>SOIL TEST PIT LOCATIONS</p>	<p>TENTATIVE PLANNED RESIDENTIAL DEVELOPMENT PLAN</p>	<p>CAMPUS LIVING by TOLL BROTHERS</p> <p>FERGUSON TOWNSHIP CENTRE COUNTY PENNSYLVANIA</p>	<p>REVISIONS</p> <table border="1" style="width: 100%; border-collapse: collapse;"> <thead> <tr> <th>No.</th> <th>Description</th> </tr> </thead> <tbody> <tr> <td> </td> <td> </td> </tr> </tbody> </table>	No.	Description			<table border="1" style="width: 100%; border-collapse: collapse;"> <tr> <td>Designer</td> <td>MMK</td> </tr> <tr> <td>Draftsman</td> <td>MMK</td> </tr> <tr> <td>Checker</td> <td>MMK</td> </tr> <tr> <td>Surveyor</td> <td>MMK</td> </tr> <tr> <td>Professional Seal</td> <td> </td> </tr> <tr> <td>Board</td> <td> </td> </tr> <tr> <td>Approved</td> <td> </td> </tr> </table>	Designer	MMK	Draftsman	MMK	Checker	MMK	Surveyor	MMK	Professional Seal		Board		Approved		<p>Copyright 2014 by the Engineer. All rights reserved. No part of this document may be reproduced or transmitted in any form or by any means, electronic, mechanical, photocopying, recording, or by any information storage and retrieval system, without the prior written permission of the Engineer. This document is the property of the Engineer and is to be used only for the project and site identified herein. The Engineer is not responsible for any errors or omissions in this document.</p> <p>www.pentterra.com</p>	<p>Pentterra ENGINEERING INC.</p> <p>CENTRAL OFFICE REGION OFFICE STATE COLLEGE, PA 16801 PH: 814-231-5235 FAX: 814-231-2308</p> <p>LANCASTER OFFICE 3904 B ABEL DRIVE COLLUMBER, PA 17512 PH: 717-522-5551 FAX: 717-522-5549</p>

Our scope of services included observing test pits within 5 proposed stormwater management areas identified by the Client, and conducting conventional infiltration tests at each of the test pit locations. Due to the subsurface conditions encountered during the work, our scope was modified to include non-conventional infiltration tests in lieu of, or in addition to, conventional infiltration tests at many of the test pit locations. The infiltration test locations, depths and methods were discussed with the Client prior to and during our investigation. The locations of the test pits are shown on a plan provided by the Client in Appendix A.
